TECHNICAL NOTE 4100

VIBRATION SURVEY OF FOUR REPRESENTATIVE TYPES OF
AIR-COOLED TURBINE BLADES

By Howard F. Calvert and Gordon T. Smith

Lewis Flight Propulsion Laboratory
Cleveland, Ohio

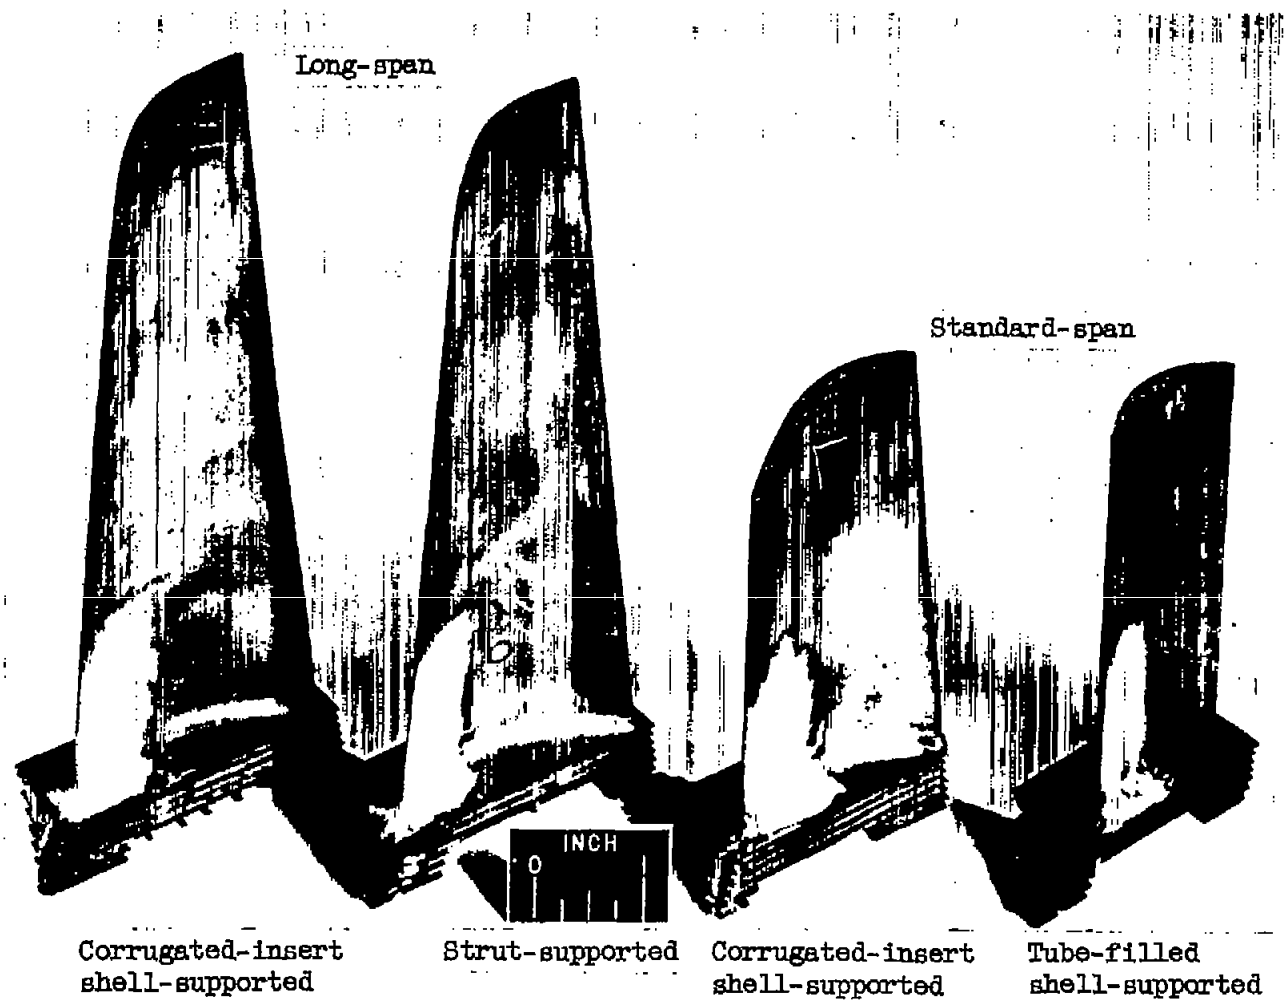
Figure 1. - Four blade types tested.

A blade of each of the four types of air-cooled turbine blades investigated is shown in figure 1. The reference name for each blade is indicated. Table I shows the sketches of the tip cross sections, and

gives the details of the materials used for the construction of blades reported herein. A shell-supported blade is one in which the outer shell is a main load-carrying member; a strut-supported blade is a blade in which an internal strut is the main member carrying the airfoil load. A corrugated-insert or tube-filled blade is a shell-supported blade in which corrugations or tubes have been inserted inside the shell to increase the heat-transfer area. The airfoil lengths of the short- or standard-span and the long-span blades were 4 and $6\frac{1}{4}$ inches, respectively. The chord length of the long-span blades was also greater than for the short-span blades. These blades were brazed structures utilizing cast bases and struts (if strut type), and sheet-metal shells and corrugations. All the blades in this investigation were new except the standard-span, tube-filled blades. These blades were used in a previous investigation and their prior running time was unknown.

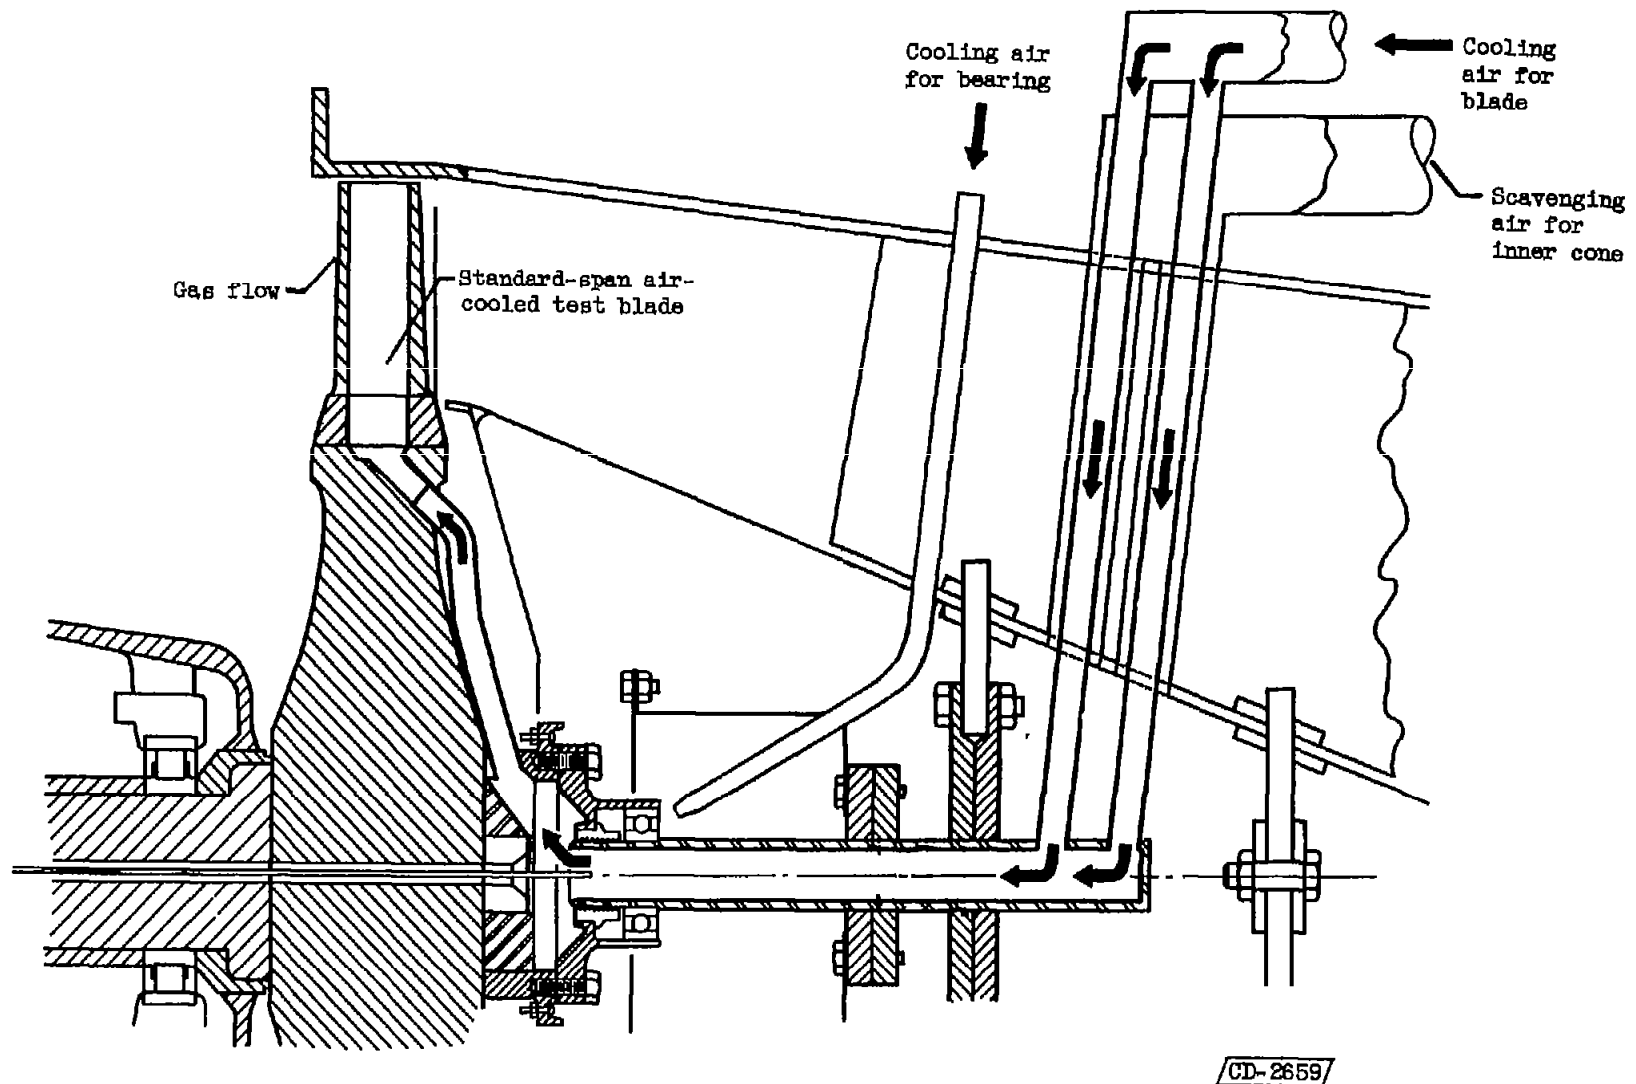
Figure 2. - Tailcone and air-supply system used for short-span blades.

The engine investigation was conducted with a turbojet engine operated in a sea-level static test stand. The test engine had a centrifugal compressor and a single-stage turbine modified to supply cooling air to two test blades located 180° apart. The cooling air was supplied to the two test blades from the rear face of the turbine wheel through a special tailcone assembly shown in figure 2. The details of the modification of the turbine rotor and tailcone are given in reference 5.

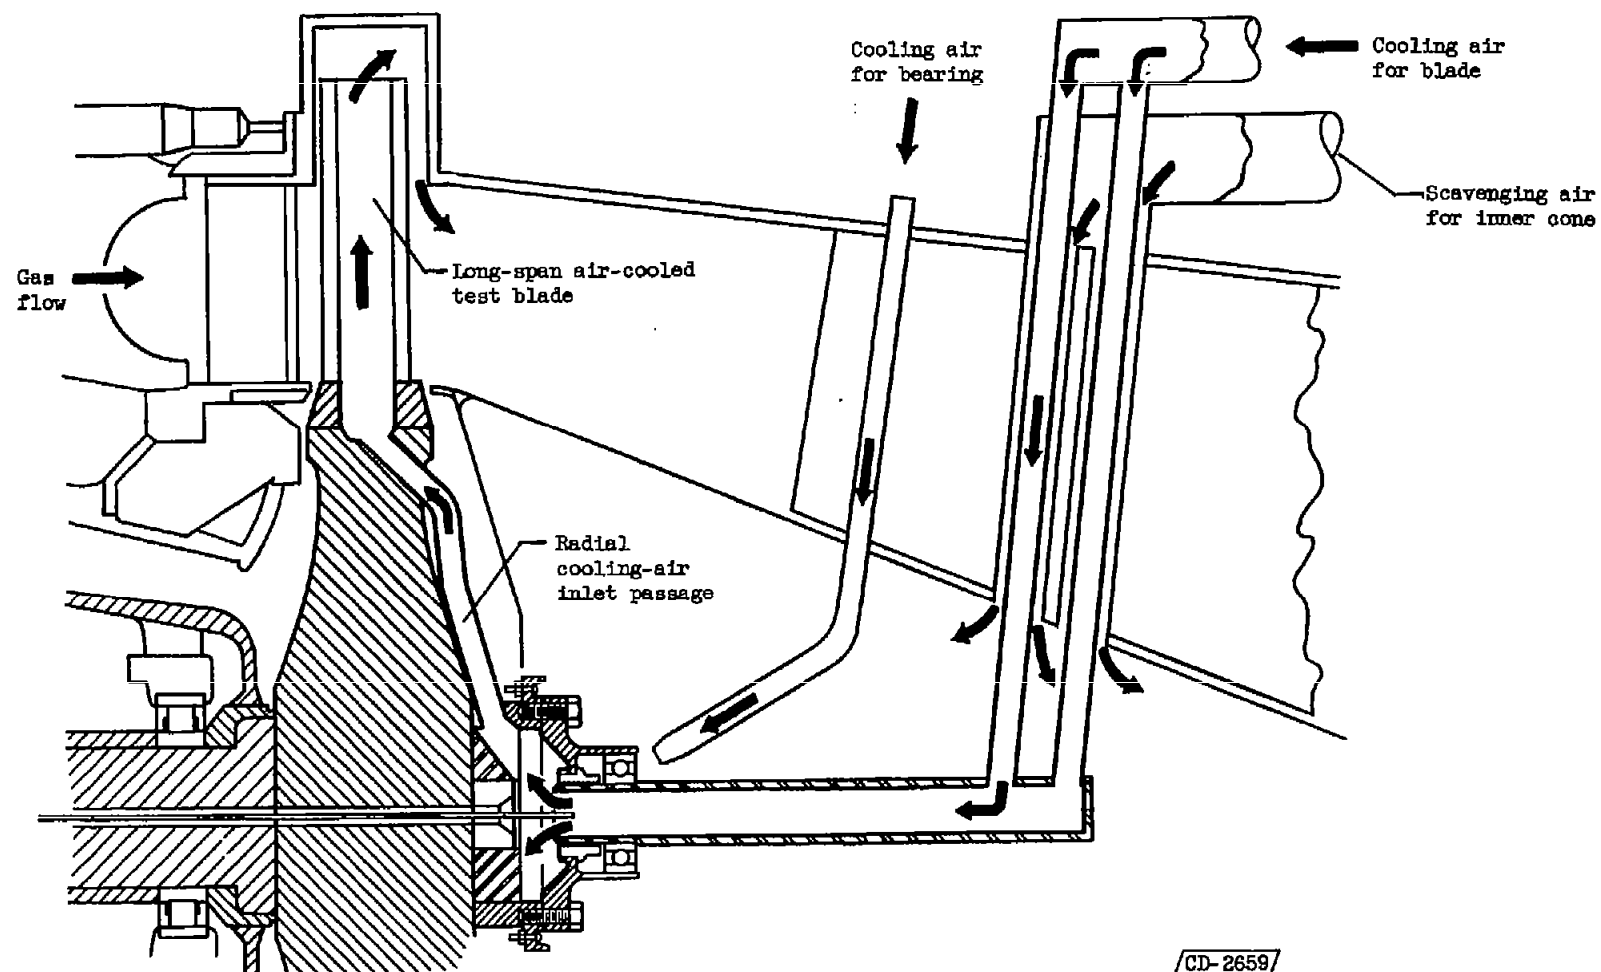
Figure 3. - Tailcone and air-supply system used for long-span blades.

The tailcone modifications reported in reference 5 were used only with the standard-span (4-in.) blades (standard production length for blades in the engine of this investigation). Additional modifications of the turbine shroud were made to accommodate the long-span ($6\frac{1}{4}$ in.) blades. Figure 3 schematically shows the special shroud that was used for this part of the investigation. The "nontest" blades were the same for the testing of all four types of blades. Therefore, the long-span blades extended radially approximately $2\frac{1}{4}$ inches beyond the tip of the other turbine blades. These portions of the test blades were partially shielded from the high-velocity working gas stream. The time and expense of providing a test facility in which a rotor, fully bladed with the long-span blades, could be tested was regarded as prohibitive. Therefore, the tailcone modifications described herein were utilized. The possible effect of this arrangement on the test results is discussed later.

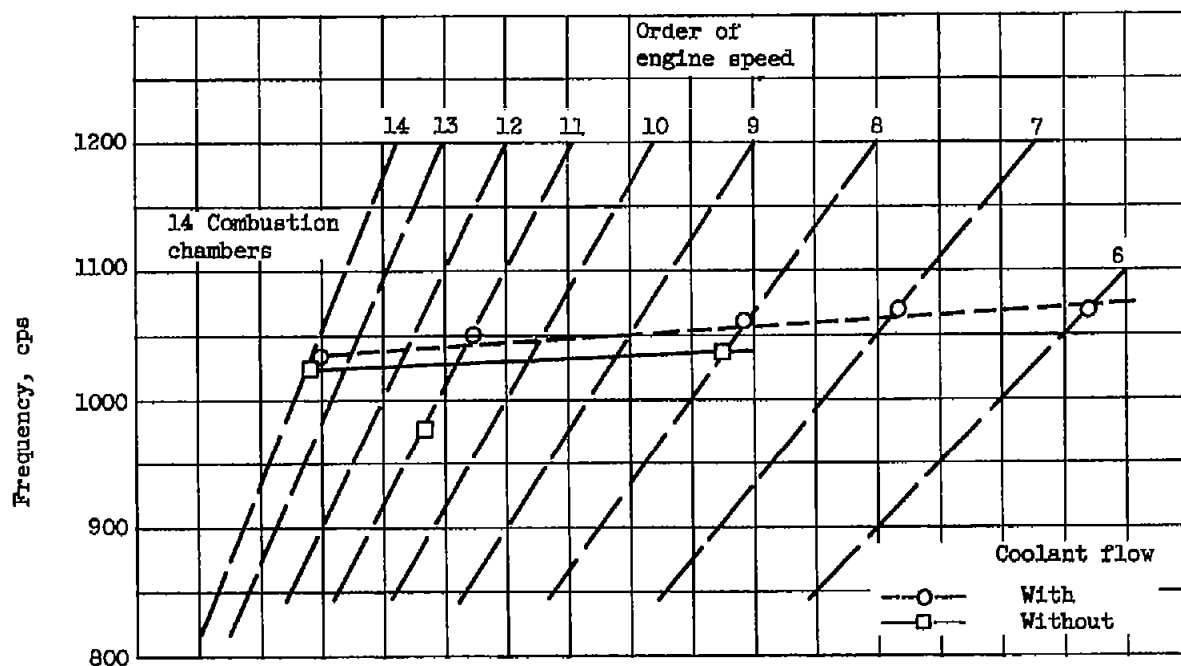
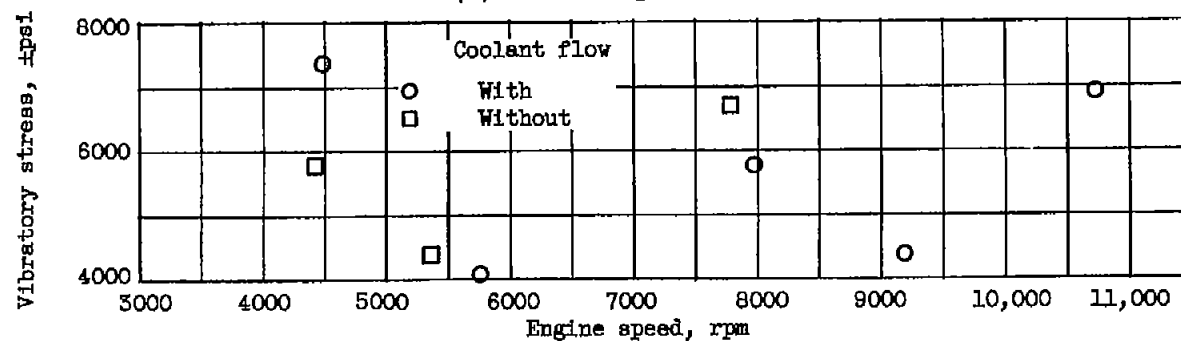
(a) Critical speed diagram.

(b) Measured vibratory stress.

Figure 4. - Measured blade frequencies and vibratory stress of standard-span tube-filled shell-supported blades.

Tube-filled shell-supported blade. - Figure 4 presents vibratory frequency and stress data. These data include the number of peaks or critical vibrations, the change in vibration frequency with coolant flow, and the vibratory stress at each critical speed. It can be noted in figure 4(a) that the sixth- and seventh-order vibrations were observed only with coolant flow. Hence, this blade type was more susceptible to vibration with coolant flow than without; that is, more vibrations were observed with coolant flow. Also, with a coolant flow rate of about 8 percent the vibrational frequency was increased approximately $2\frac{1}{2}$ percent. For example, with the eighth-order vibration the frequency was increased from approximately 1035 to 1060 cycles per second. Calculations based on temperature measurements from previous heat-transfer investigations indicated that the frequency increase was due to the increase in the blade-material modulus of elasticity with a decrease in blade-material temperature. The fourteenth-order vibration was probably excited by the presence of 14 combustor cans.

The peak vibratory stresses reported in figure 4(b) varied between ± 4000 to ± 7500 psi; however, the peak stress measured either with or without coolant flow was approximately the same, indicating that coolant flow had little effect on peak vibratory stress. These peak vibrations occurred over a narrow speed range and the resonant peaks were sharp and often difficult to obtain. Figure 5(a) presents a typical oscillogram showing the resonant-type vibration signal obtained with the tube-filled-type, air-cooled turbine blade.

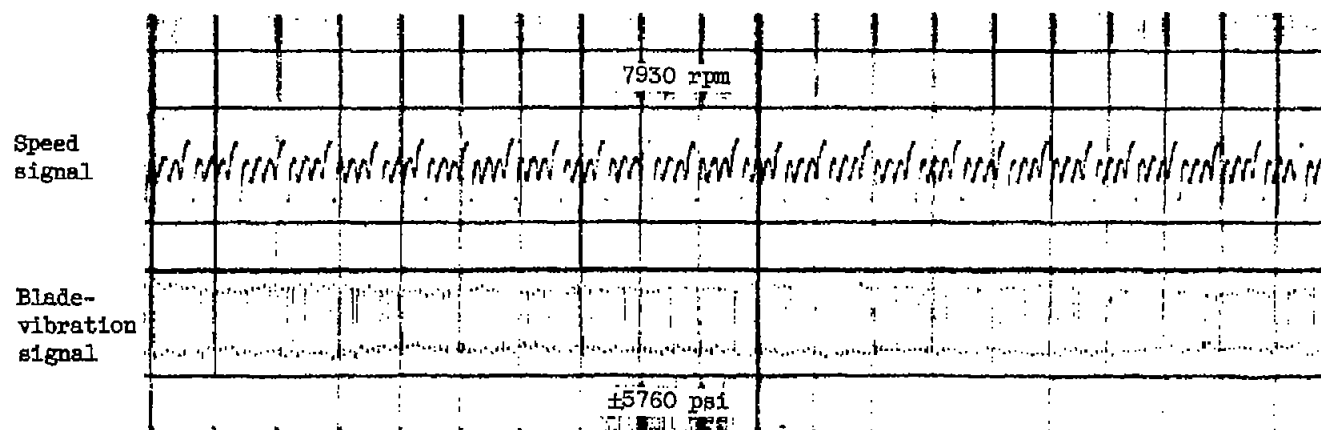
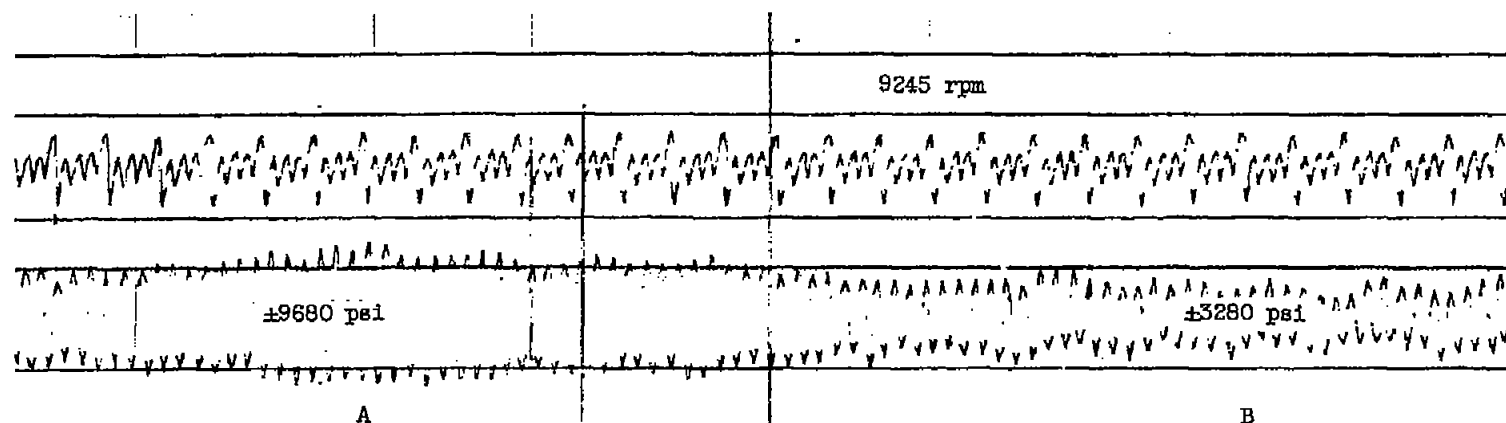
(a) Resonant-type vibration characteristic of standard-span tube-filled shell-supported blade.

(b) Characteristic vibration signal for long-span, strut-supported blade.

Figure 5. - Typical oscillograms of air-cooled turbine blades.

signals for the corrugated-insert, shell-supported and solid blades were the same as for the tube-filled blade shown in figure 5.

In figure 7(b) the maximum vibratory stress was approximately ± 9680 psi at 9250 rpm without coolant flow. At speeds below 8700 rpm, the maximum stresses were measured with coolant flow. Figure 5(b) presents a typical oscillogram showing the characteristic vibration for a long-span strut-supported blade. Close examination of figure 5 shows that the amplitude of the long-span blade vibration is constantly changing. With the standard-span blade the amplitude was relatively constant. In figure 5(b) the stresses vary from approximately ± 3280 to ± 9680 psi, and the stresses varied in a like manner at all speeds. The excitation of these blades may have been associated with or influenced by the testing environment described in APPARATUS AND INSTRUMENTATION and shown in figure 3. The varying-amplitude-type vibration signal is considered to be associated with a stalling condition in axial-flow compressors. Since the tips of

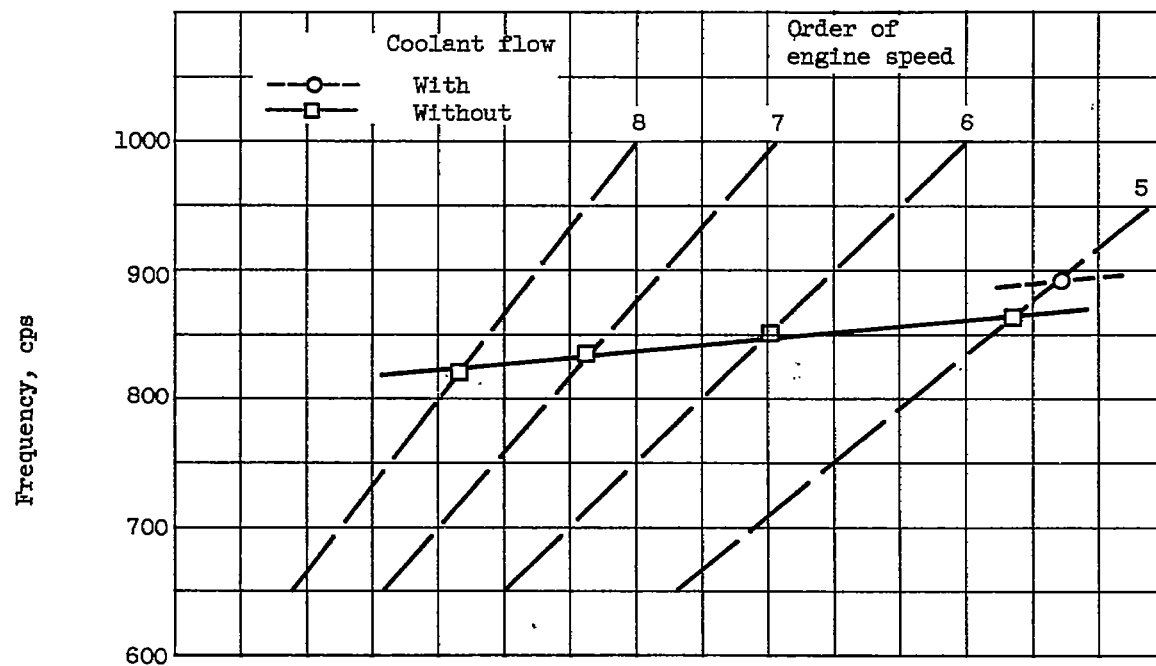
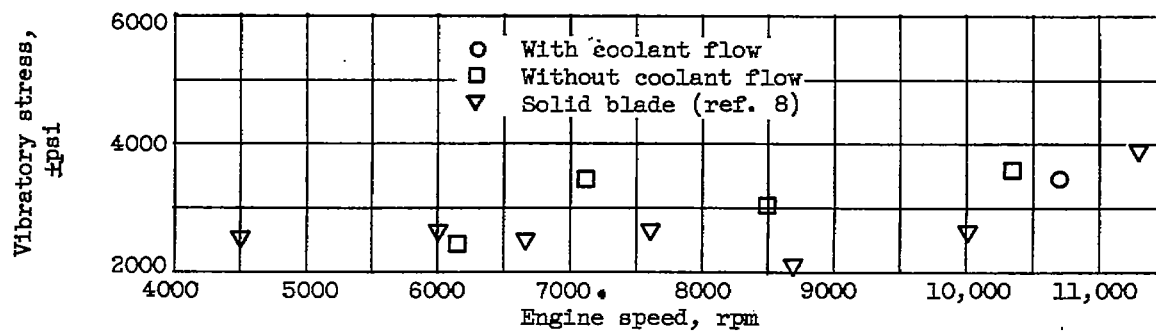
(a) Critical speed diagram.

(b) Measured vibratory stress.

Figure 6. - Measured blade frequencies and vibratory stresses in standard-span corrugated-insert shell-supported blade.

Corrugated-insert shell-supported blade. - The frequency and stress data are plotted in figure 6. The only vibration that was observed when the corrugated-insert shell-supported blade was operated with coolant flow was the fifth-order vibration. The fifth, sixth, seventh, and eighth orders of vibration were observed when the blade was operated without coolant flow. Therefore, this blade type was more susceptible to vibration when operated without coolant flow, or just the opposite result of that obtained with the tube-filled blade. The vibrational frequency was raised about 3 percent when the blade was operated with coolant flow.

The peak vibratory stresses measured were approximately ± 3500 psi (fig. 6(b)) or approximately one-half as high as for the tube-filled blades. These peak vibrations also occurred over a narrow speed range. Also plotted in figure 6(b) are the vibratory stresses measured in another investigation and reported in figure 4 of reference 8. These data were obtained with high-temperature strain gages mounted on solid blades used in the same type engine as this investigation. The vibratory stresses were of approximately the same magnitude as those reported herein for the corrugated-insert shell-supported blade. The characteristic vibration

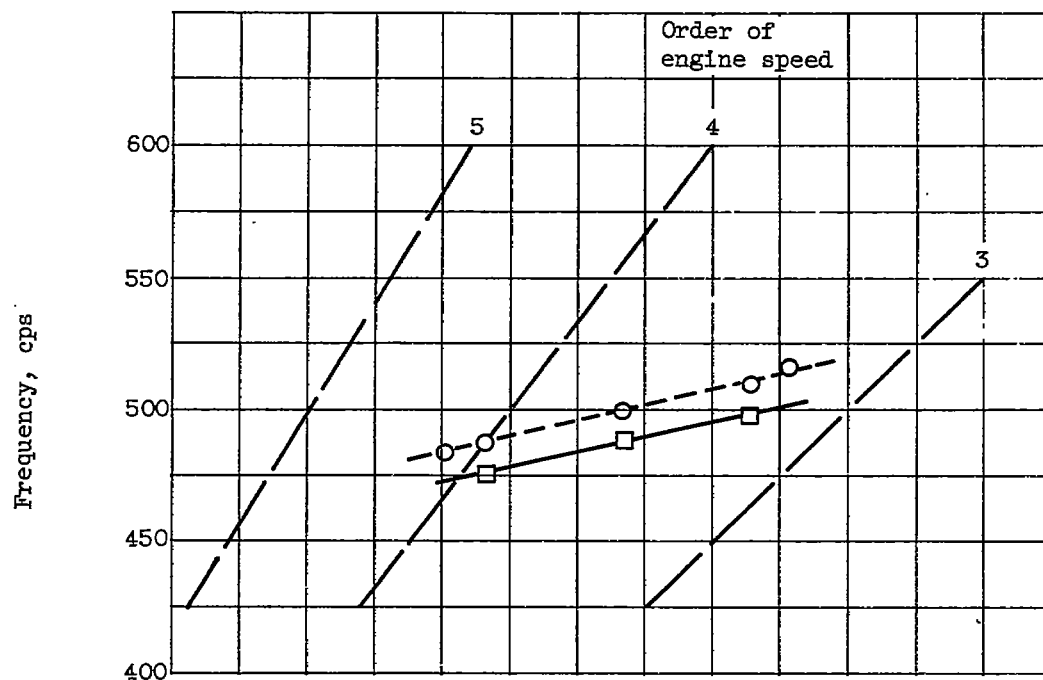
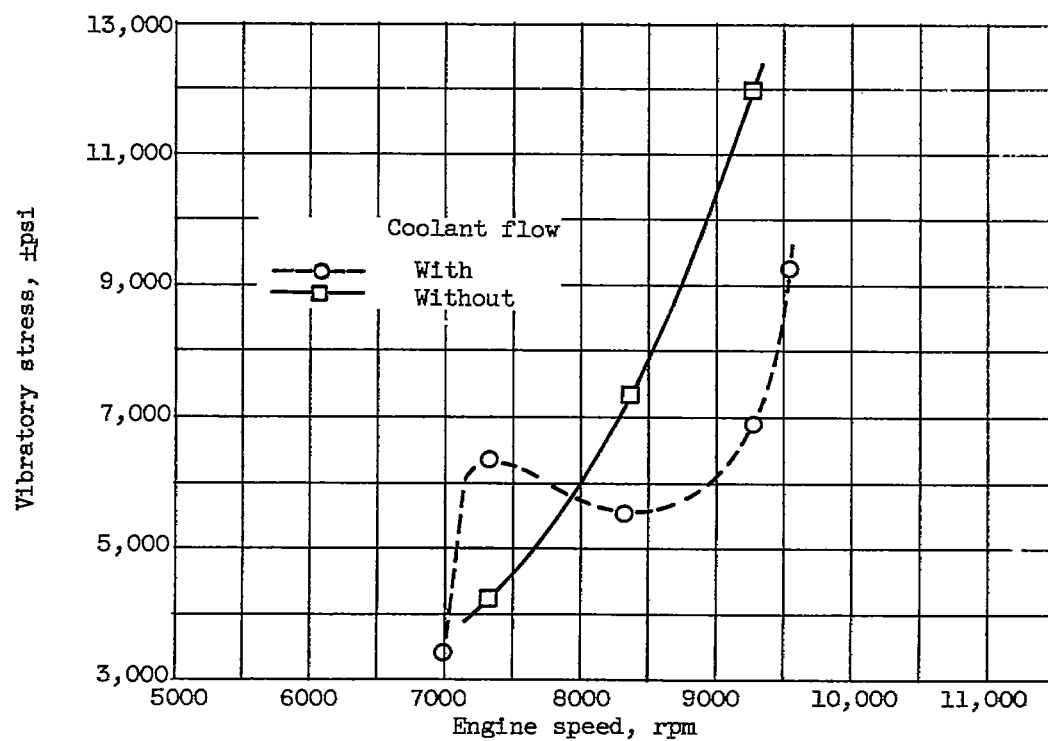
(a) Critical speed diagram.

(b) Measured vibratory stress.

Figure 8. - Measured blade frequencies and vibratory stresses in long-span corrugated-shell-supported blade.

Corrugated-insert shell-supported blades. The vibration data for the corrugated-insert shell-supported blades are reported in figure 8. The vibration frequency and character of the strain-gage signals were the same for both the strut-supported and corrugated-insert, shell-supported long-span blades. That is, the blades were vibrating at all speeds with an irregular amplitude. With the corrugated-insert, shell-supported blades, the vibration frequency was increased approximately 3 percent with coolant flow.

The maximum vibratory stress of $\pm 12,000$ psi (fig. 8(b)) was measured at 9250 rpm without coolant flow. Above 8000 rpm the stresses increased very rapidly with increased engine speed either with or without coolant flow.

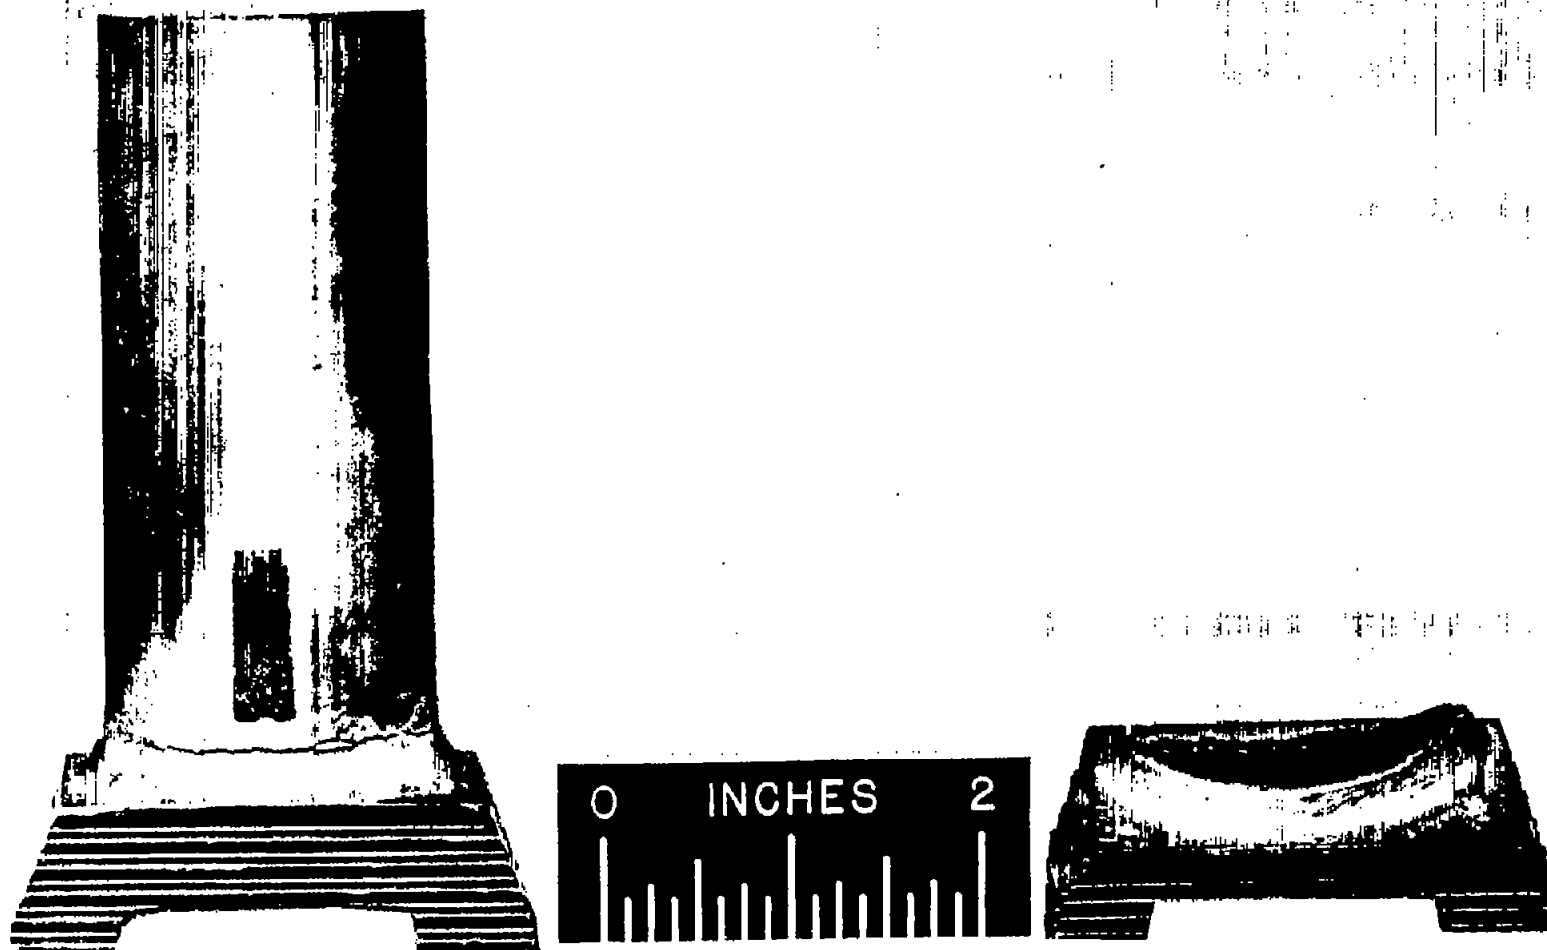
Figure 9. - Typical failures of short-span tube-filled shell-supported blades.

Tube-filled shell-supported blade. - Figure 9 shows a typical tube-blade failure obtained during engine operation and reported in reference 1. Blades 1 and 2 of static investigation reported herein (table II) also exhibited fatigue failures at the same location. With a vibratory stress of $\pm 10,000$ psi, blade 2 failed in only $7\frac{1}{2}$ hours. Figure 4 shows that vibratory stresses as high as approximately ± 7500 psi were measured during engine operation. A vibratory stress of ± 7500 psi may appear to be too low to cause blade failure; however, because of stress concentrations at the fillet, the stress at the point of failure would be many times higher or high enough to cause blade failure.
